Attachment 2 - Photos

The photos below show damage to the Analysis room caused by the hydrogen leak/explosion.

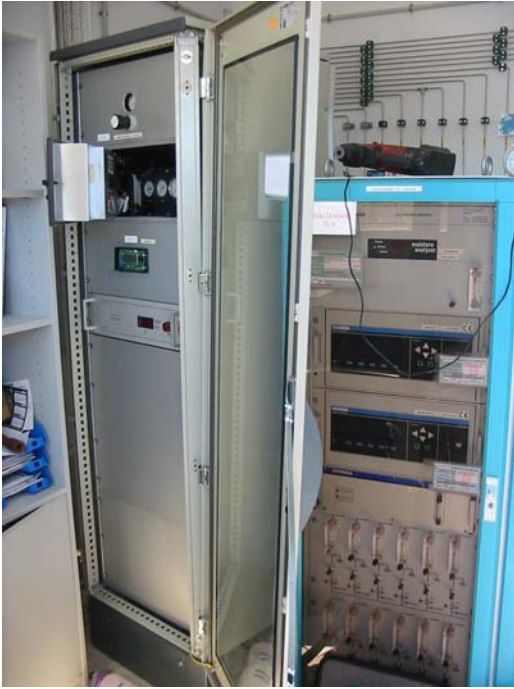
Photo 1 – Analyzer cabinet door blown open by internal hydrogen explosion.

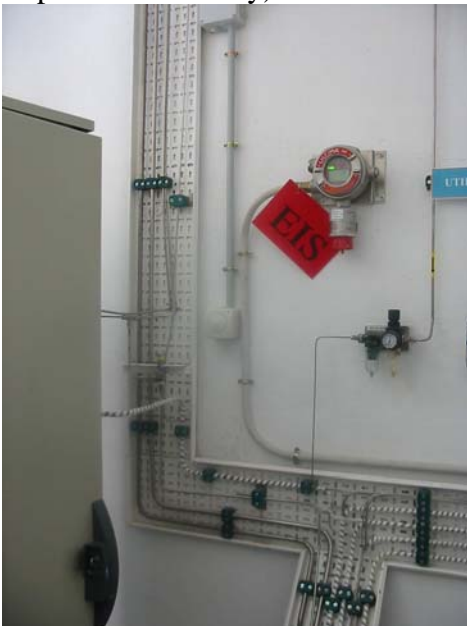
Photo 2 – Hydrogen shut-off valve in the Analysis room with safety label (EIS – Element Important for Safety)

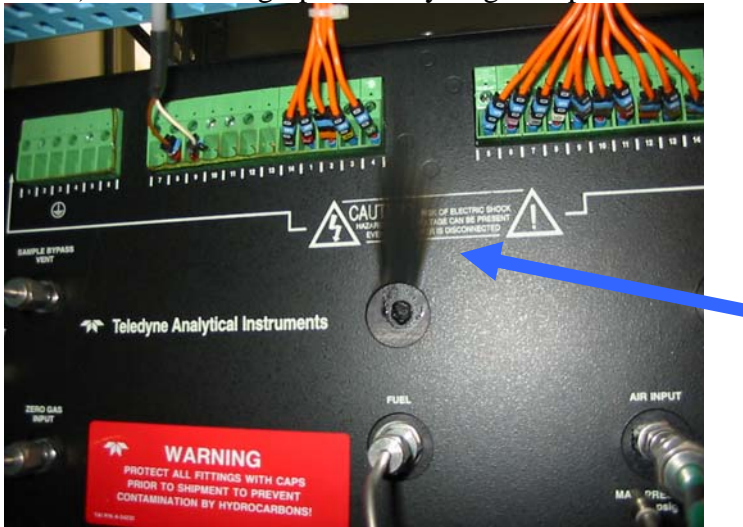
Photo 3 – Detail view of chromatograph. Note flame / combustion marks (see blue arrow) on chromatograph from hydrogen explosion.

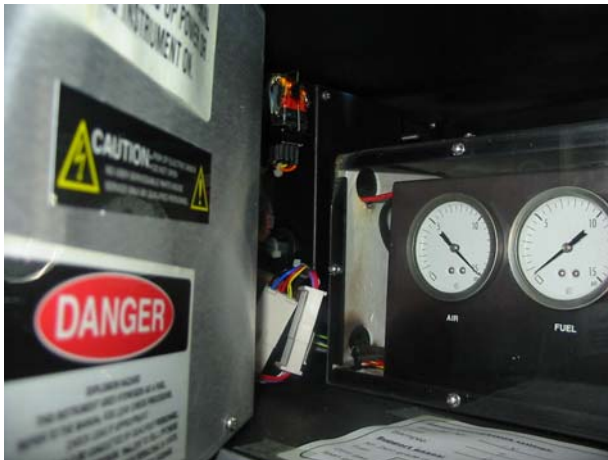
Photo 4 – General View

More Photos (3, 4, 4a, 4b, 4c, 5) – Various details of analysis room equipment after the hydrogen explosion showing damage.
