Hydrogen Explosion Due to Inadequate Maintenance

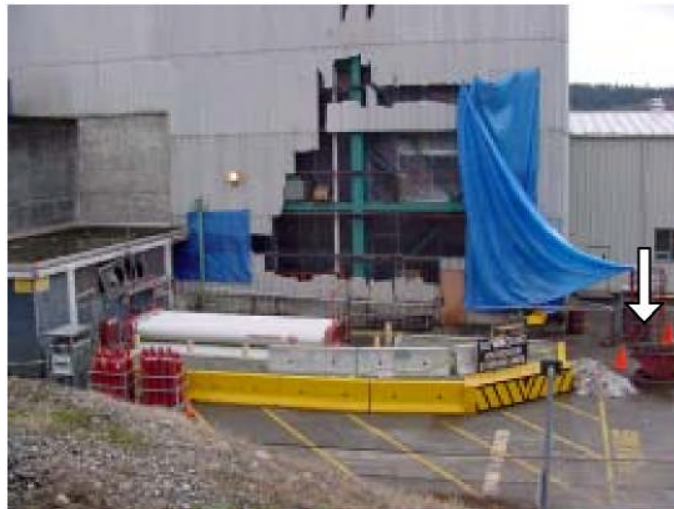
The explosion damaged a wall adjacent to the hydrogen storage assembly (see Figure 1 below). The investigation revealed that the explosion was the consequence of deficiencies in components integral to the hydrogen storage assembly – a vent cap failed, allowing water to accumulate in the vent pipe. The water froze and damaged the burst disc, ultimately allowing the hydrogen to escape containment. The pipe through which the hydrogen was vented was improperly installed. This promoted the formation and ignition of an explosive mixture of air and hydrogen.

Figure 1. Blast damage sustained by the turbine house transite wall. The arrow points to the approximate location of the worker nearest to the hydrogen assembly when the explosion occurred.

On 28 January 2002 at approximately 13:10 hours, hydrogen escaped from containment in the hydrogen storage area. An explosive mixture of hydrogen and air formed before ignition occurred. Damage caused by the resulting explosion is shown in Figure 1 above. The explosion occurred in an area through which workers walk. A worker had exited the door at the northwest corner of the turbine house (the door located beneath the damaged wall in Figure 1) and walked west for no more than about 10 seconds, reaching the location of the arrow shown in Figure 1, when the explosion occurred. The explosion’s pressure wave jarred this worker, but did not knock him down.

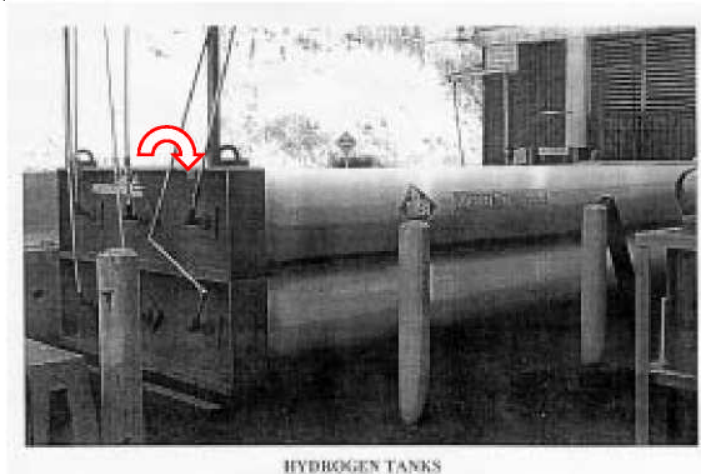
Figure 2. A photograph of the hydrogen storage tubes taken prior to the date of the subject incident. Note the No. 6 vent pipe contains two 90° bends, unlike the other five vent pipes. Also, this vent pipe is secured to the tube frame by only one of the available two U-clamps (the arrow points to the second U-clamp available, but not used, to secure the No. 6 vent pipe to the tube frame).

The vent pipe originally fitted to the No. 6 hydrogen tube was found leaning against the barricade about 8 feet north of the No. 6 hydrogen tube. All three sections of tubing comprising this vent pipe were bent. Analysis of this pipe configuration revealed that hydrogen must have initially briefly flowed through this vent pipe to cause the pipe to separate from the burst disc valve body. The tendency for this vent pipe to separate from the valve body was enhanced by this pipe assembly being fixed to the tube frame by only one of the available two clamps (Figure 2 above) - two clamps being the standard configuration used to secure all other vent pipes to the frame.

Further analysis revealed that if the vent pipe were designed and installed to withstand the reaction forces generated by the flow of hydrogen, as per the requirements of the Boiler and Pressure Vessel Act (1987, ASME B31 .3, Part 322.6.2), then it would not have separated from valve body in response to the hydrogen release. Furthermore, if the hydrogen had vented through the pipe, then it is likely that it would have simply vented to atmosphere and dissipated in air, or ignited and burned at the top of the vent pipe. Instead, the hydrogen released from the valve body directly to atmosphere once the vent pipe parted from the assembly. This release mode likely increased the chance of the explosion occurring, compared to the chance of an explosion occurring when hydrogen releases, as designed, vertically through a vent pipe.

The vent pipe's configuration (two 90° bends) led to reaction forces being generated, in response to the flow of hydrogen that exceeded the ability of the single U-clamp to secure the pipe to the tube frame. This force imbalance caused the vent pipe to separate from the burst disc valve. The hydrogen released from the valve body directly to atmosphere once the vent pipe parted from the assembly. This release mode likely increased the chance of the explosion occurring, compared to the chance of an explosion occurring when hydrogen releases through a vent pipe.

- a. As a corrective action, eliminate the burst discs and their associated vent pipes from the hydrogen storage assembly.
 5. During the installation and ongoing service life of the hydrogen storage tubes, plant management relied on the hydrogen supplier to ensure that the hydrogen storage assembly met applicable codes, standards, and regulations. Plant management, however, did not examine the methods by which the hydrogen supplier intended to discharge this responsibility. Such an examination could have led to the supplier reviewing the entire hydrogen storage assembly, possibly identifying the substandard vent tube installation, and consequently could have prevented, or reduced the chance of occurrence of the hydrogen explosion.

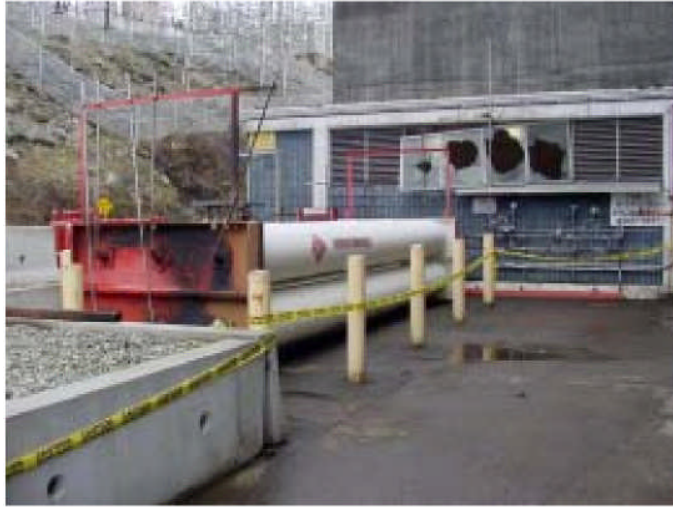
Figure 3. A burn pattern on the hydrogen tube six pack west frame. Note the vent pipe is missing from tube No. 6.

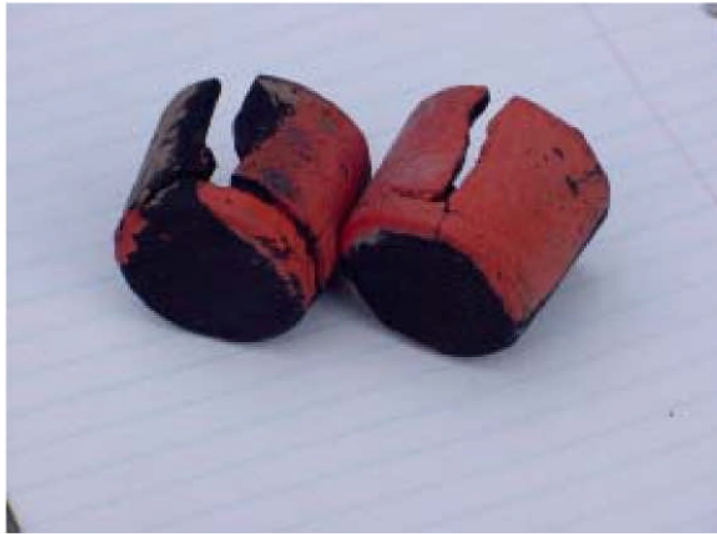
Water could only access the burst disc after passing the vent pipe cap and a plastic weather membrane integral to the burst disc valve body. Caps were found on only two of the six burst disc vent pipes (on the pipes venting the No. 1 and 4 hydrogen tubes). Two additional caps were found on the ground under the tube six-pack. The four recovered caps were constructed of rubber and all were markedly degraded; each cap contained large cracks on their side surfaces (the two caps found on the ground are shown in Figure 4 below). Two coats of paint, red over brown, covered the black rubber caps; brown paint was present on the crack surfaces – indicating both coats of paint were applied to the caps after the cracks had formed! The

degraded state of these caps would have readily allowed water to enter the vent pipes.

Figure 4. Two vent caps, typical of the four vent caps found at the site.

The uncontrolled release of hydrogen occurred as a result of the premature rupture of the No. 6 hydrogen storage tube's burst disc. This disc failed in response to being overloaded by mechanical stresses developed as water expanded and formed ice while in direct contact with the burst disc. It was the degraded condition of the vent cap that enabled water to access the burst disc.

- a. As a corrective action, eliminate burst discs from hydrogen storage assembly. Redesign venting system for the pressure relief valves to prevent or inhibit moisture build up and allow moisture drainage.
